BUILDING SCIENCE

Infrared Pictures

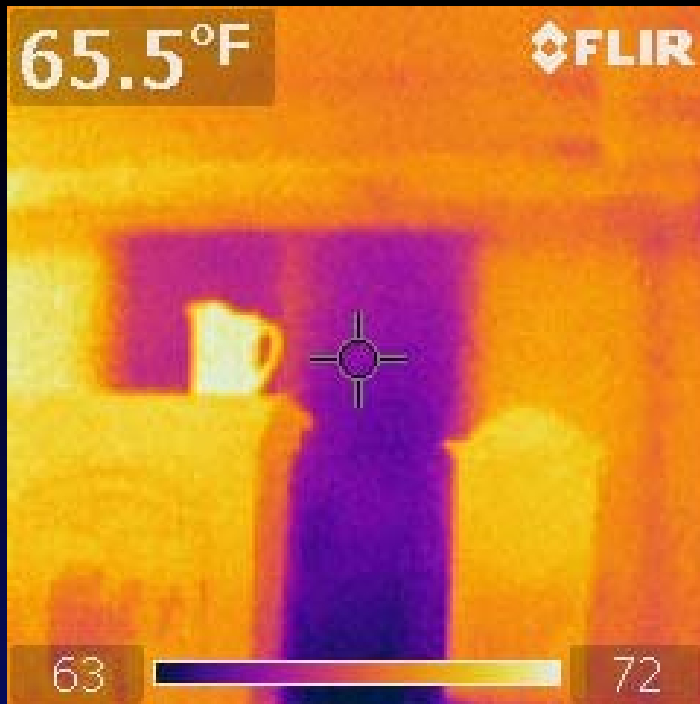
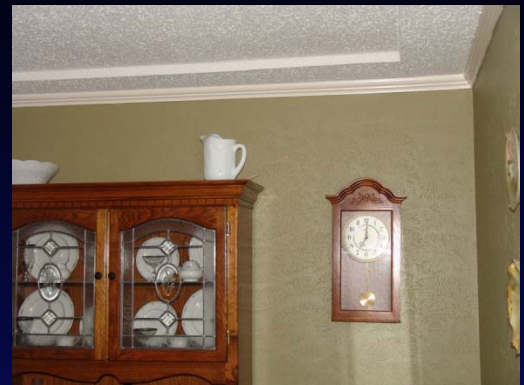
Partition wall between Dining Room and Garage.

This home was insulated with fiberglass and before the sheetrock could be installed, the batting in this wall blew out due to high winds in the area. The crew installing the sheet rock did not take the initiative to put the insulation back in place before covering this section

Demilec's spray foam insulation will not blow away in normal conditions

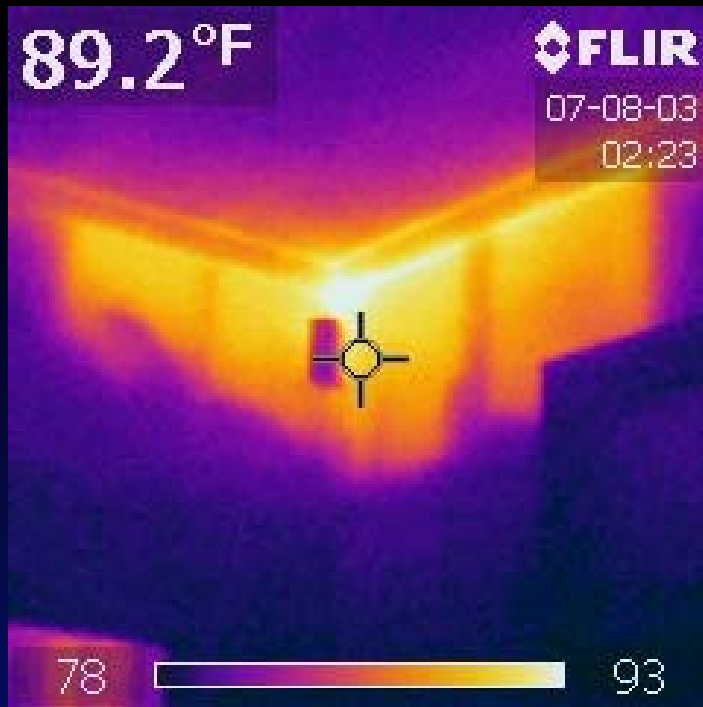
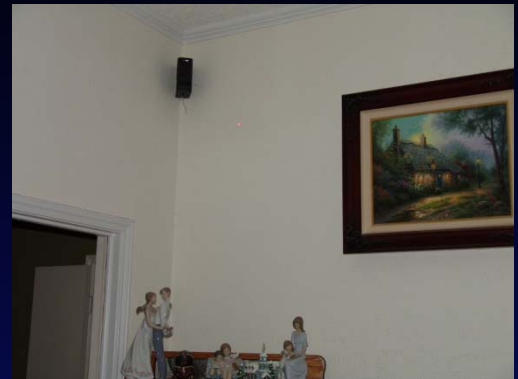
Knee Wall in Living Room

This is a knee wall extending up two feet to give the room a more open feel; however, over time the fiberglass began to fall away from the wall placing an increased heat load on this room.

Using Demilec's foam insulation will remain in place for the life of the home totally eliminating this issue in the future

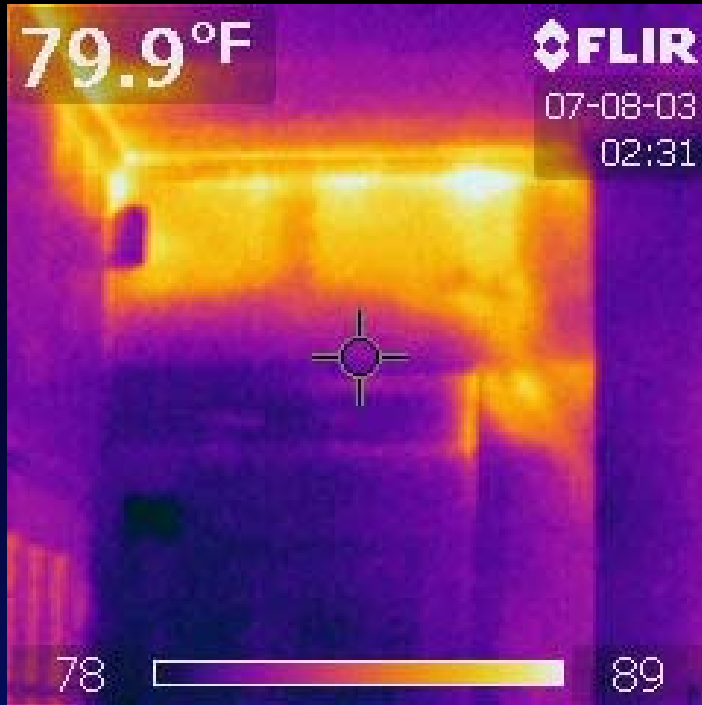
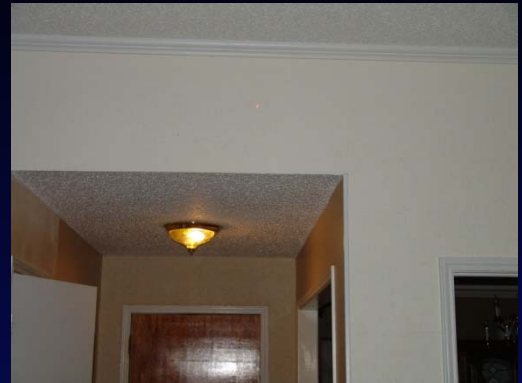
Air Infiltration

This is an excellent example of insulation that allows air intrusion.

This picture was taken on a hot summer day and shows very hot attic air being pulled down into HVAC return system.

This severely decreases the efficiency of the HVAC system.

Demilec's foam insulation is also an air barrier.

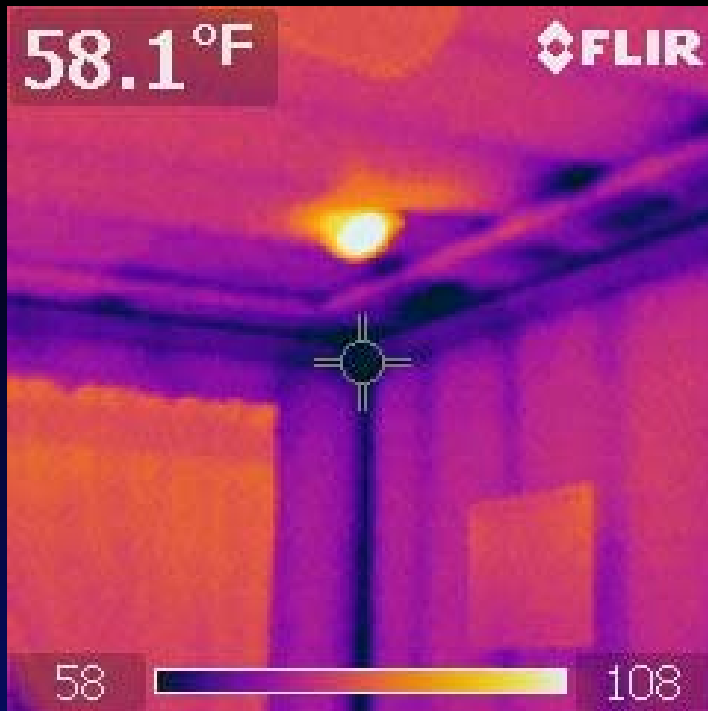
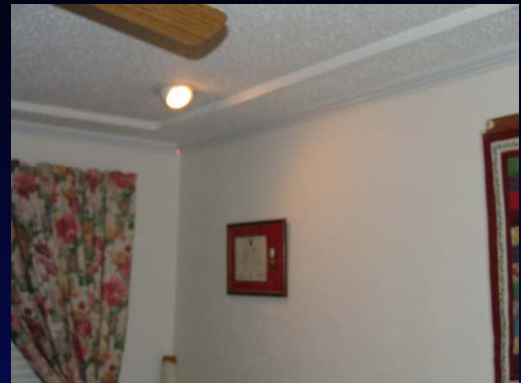
Loose Fill Insulation Blown Away From Edge

Loose fill insulation blown in without installing baffles will tend to be blown back away from the soffits reducing or eliminating any insulation value provided.

Demilec's foam insulation can be applied directly to the ceiling or the roof deck without any concern of it being affected by normal wind conditions.

The foam insulation will remain in place.

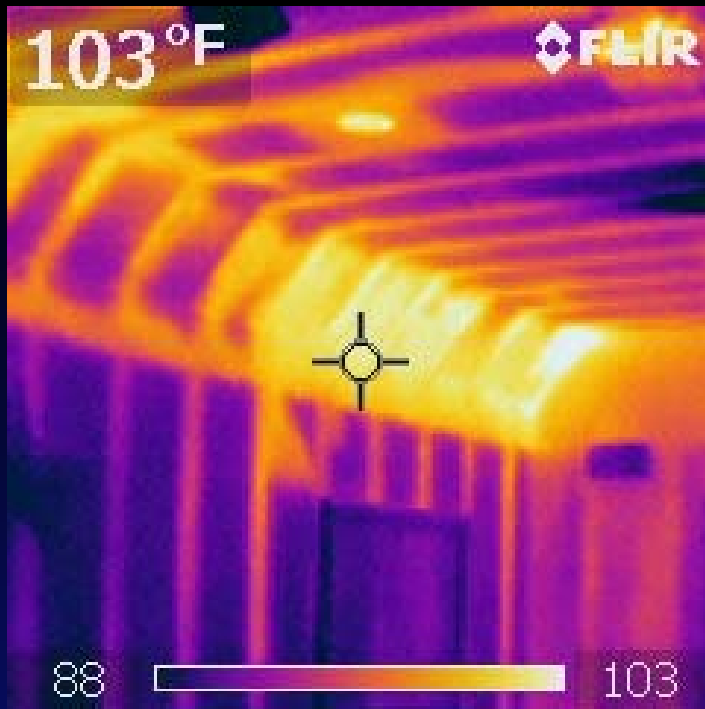
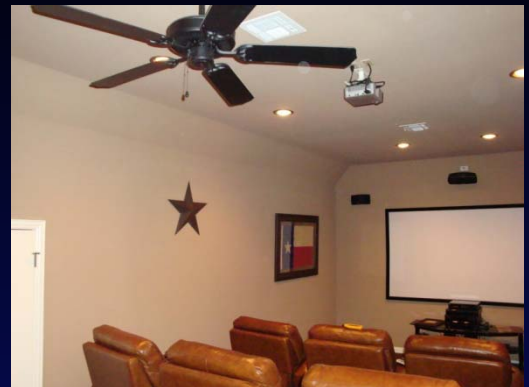
Thermal Break

This home is constructed using metal framing without the use of a thermal break between ambient conditions and the metal framework.

Homes constructed from metal framing should install a thermal break between the metal framing and the exterior surface to reduce thermal bridging.

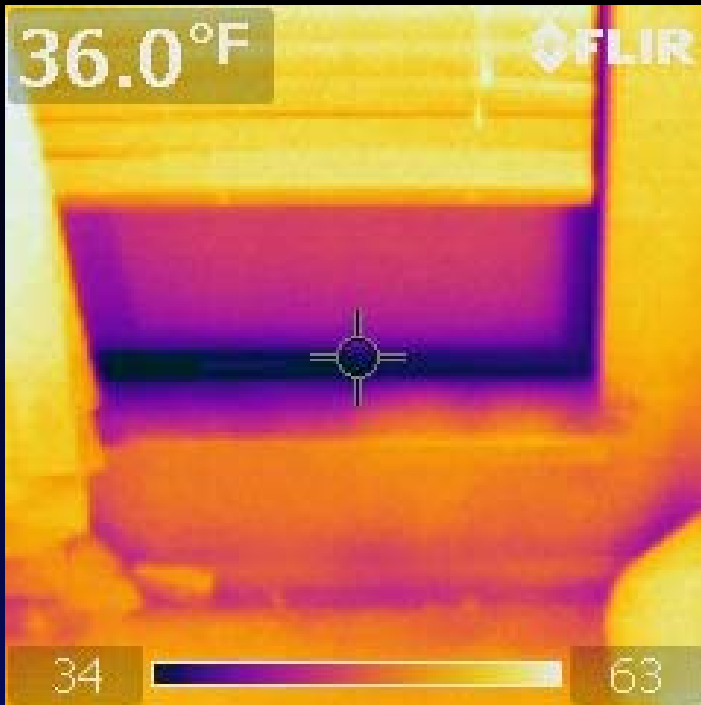
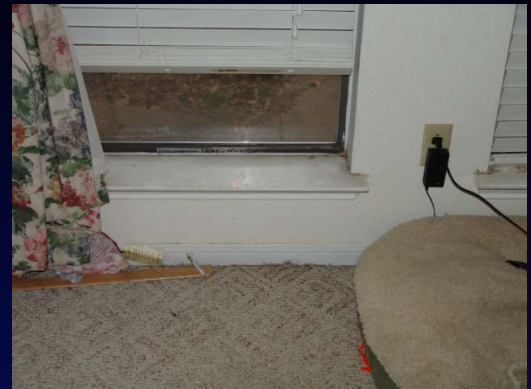
Thermal Break

Windows installed in this home are dual pane , aluminum frame without a thermal break. Notice the temperature of the metal frame and the adjoining surface.

Wood or vinyl framed windows would perform much better in reducing the thermal bridging; however, if you must use a metal framed window, insure the metal frame is manufactured with a thermal break.

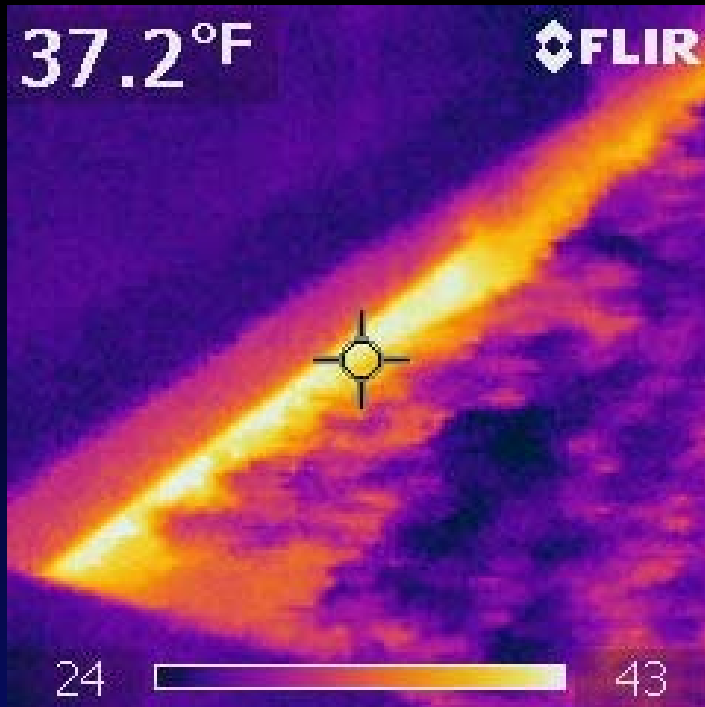
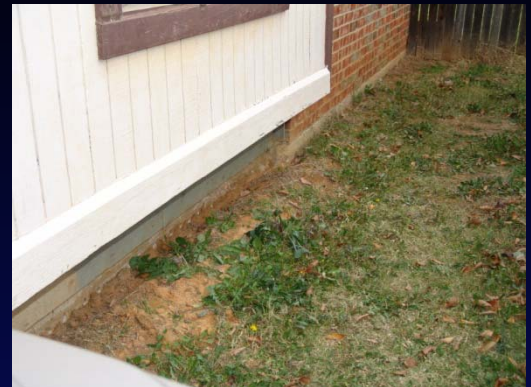
Thermal Transfer

This slab on grade home does not have a thermal barrier in place between the slab and ground. Notice the amount of heat being pulled from the home and released to ambient conditions.

Many homes today are installing thermal barriers between the slab and grade reducing the thermal bridging phenomena. Doing this will prevent the conditioned temperature from being effected by ambient conditions.
